PRELIMINARY TESTS OF INFLATABLE LIFERAFTS
FOR STABILITY IN HIGH WINDS

December 1, 1977

DEPARTMENT OF TRANSPORTATION
UNITED STATES COAST GUARD

OFFICE OF MERCHANT MARINE SAFETY
Washington, D.C. 20590

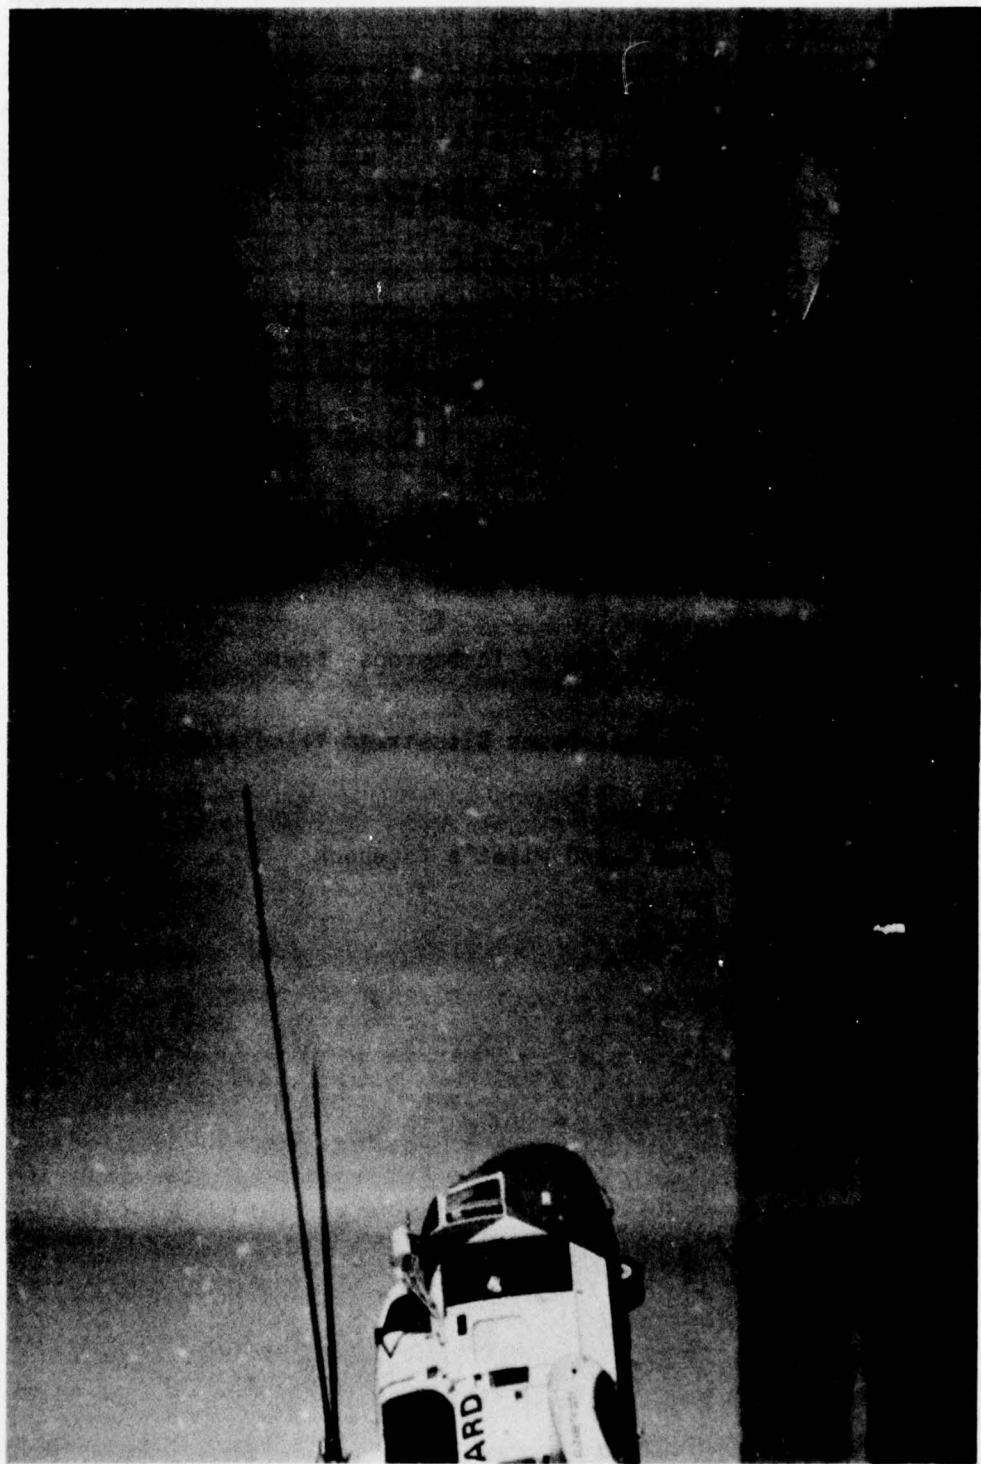
(7) All weights on one side of raft. Helicopter approached raft on its weighted side at 5-foot altitude. Raft lifted one end but remained upright. Test conducted second time: helicopter came in on nonweighted side of the raft, which made one quick 30° lift of one side and came down upright. Refer to Fig. 5.

Figure 5- Hendry '25' Lifting: Refer to Table II(7) (NASA Photograph)

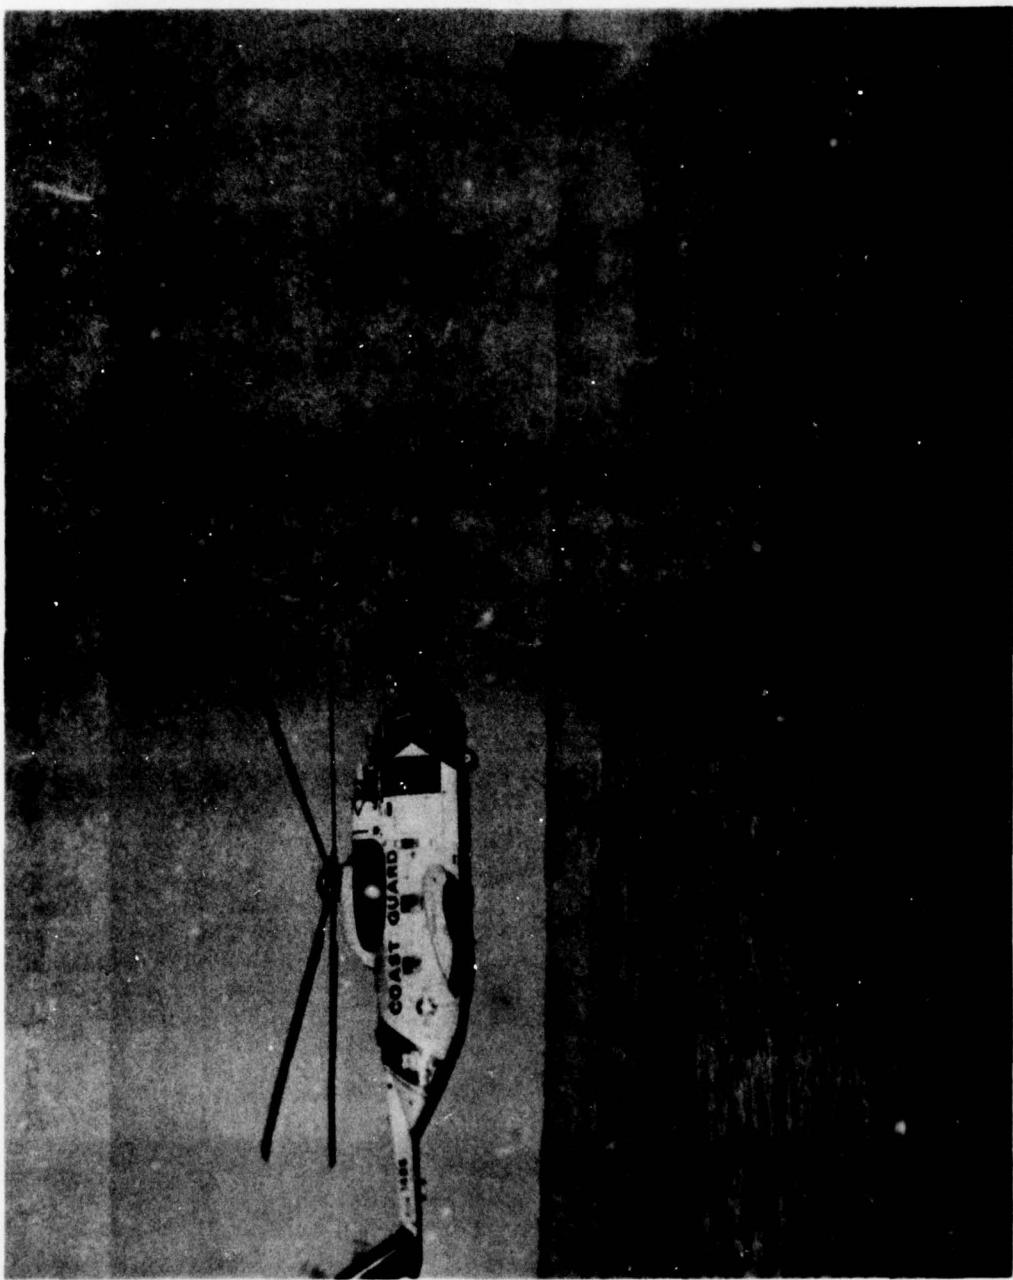
(8) Raft lifted up on beam end and dropped back upright. Refer to Fig. 6.

Figure 6- Hendry '25' on Beam Ends: Refer to Table II(8) (NASA Photograph)

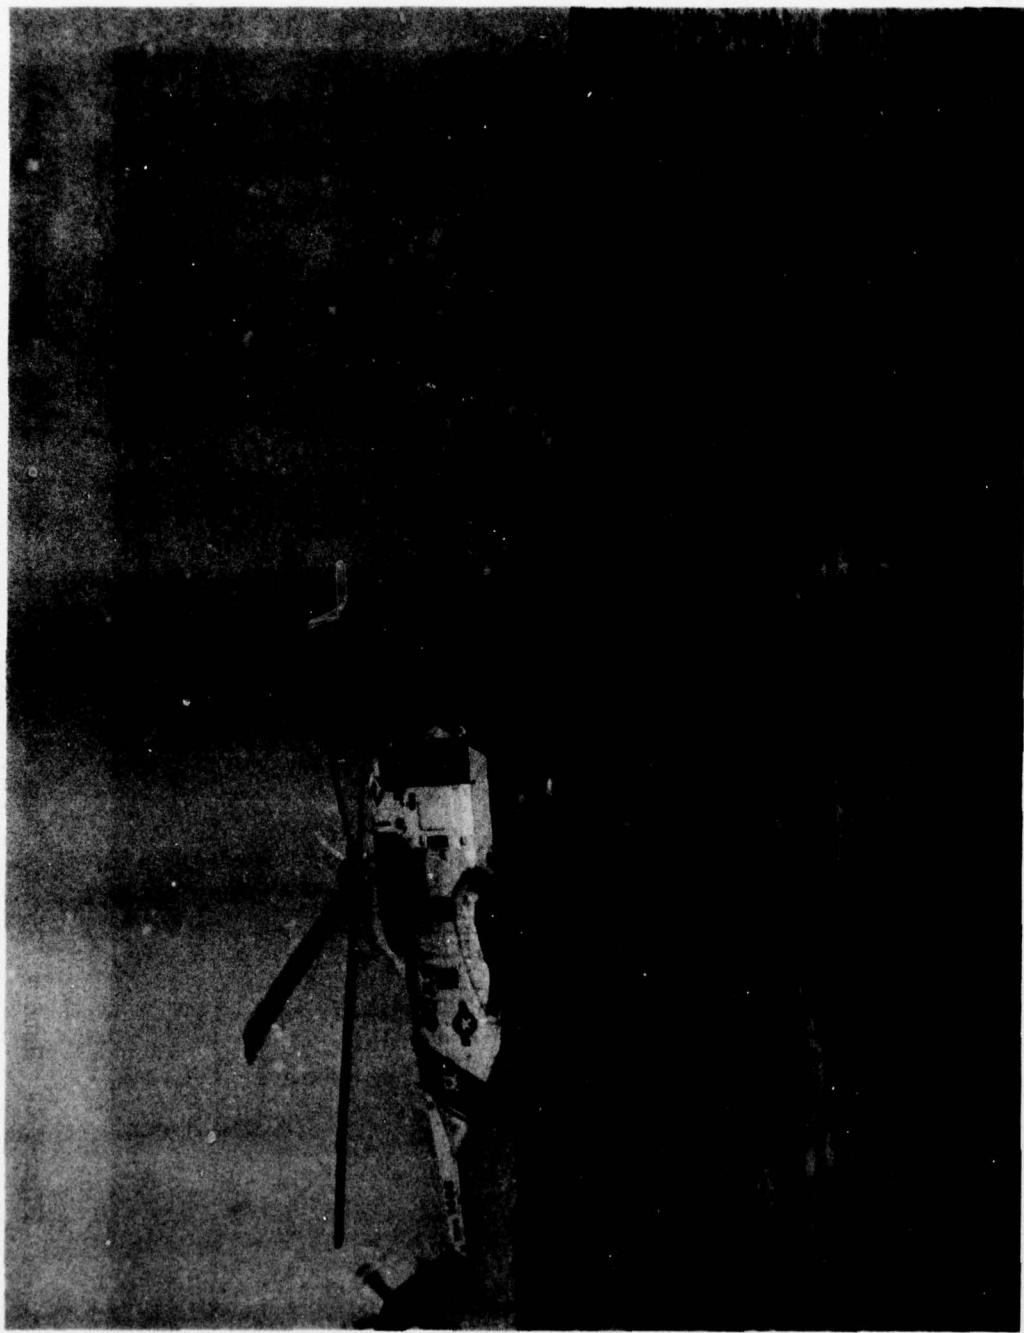
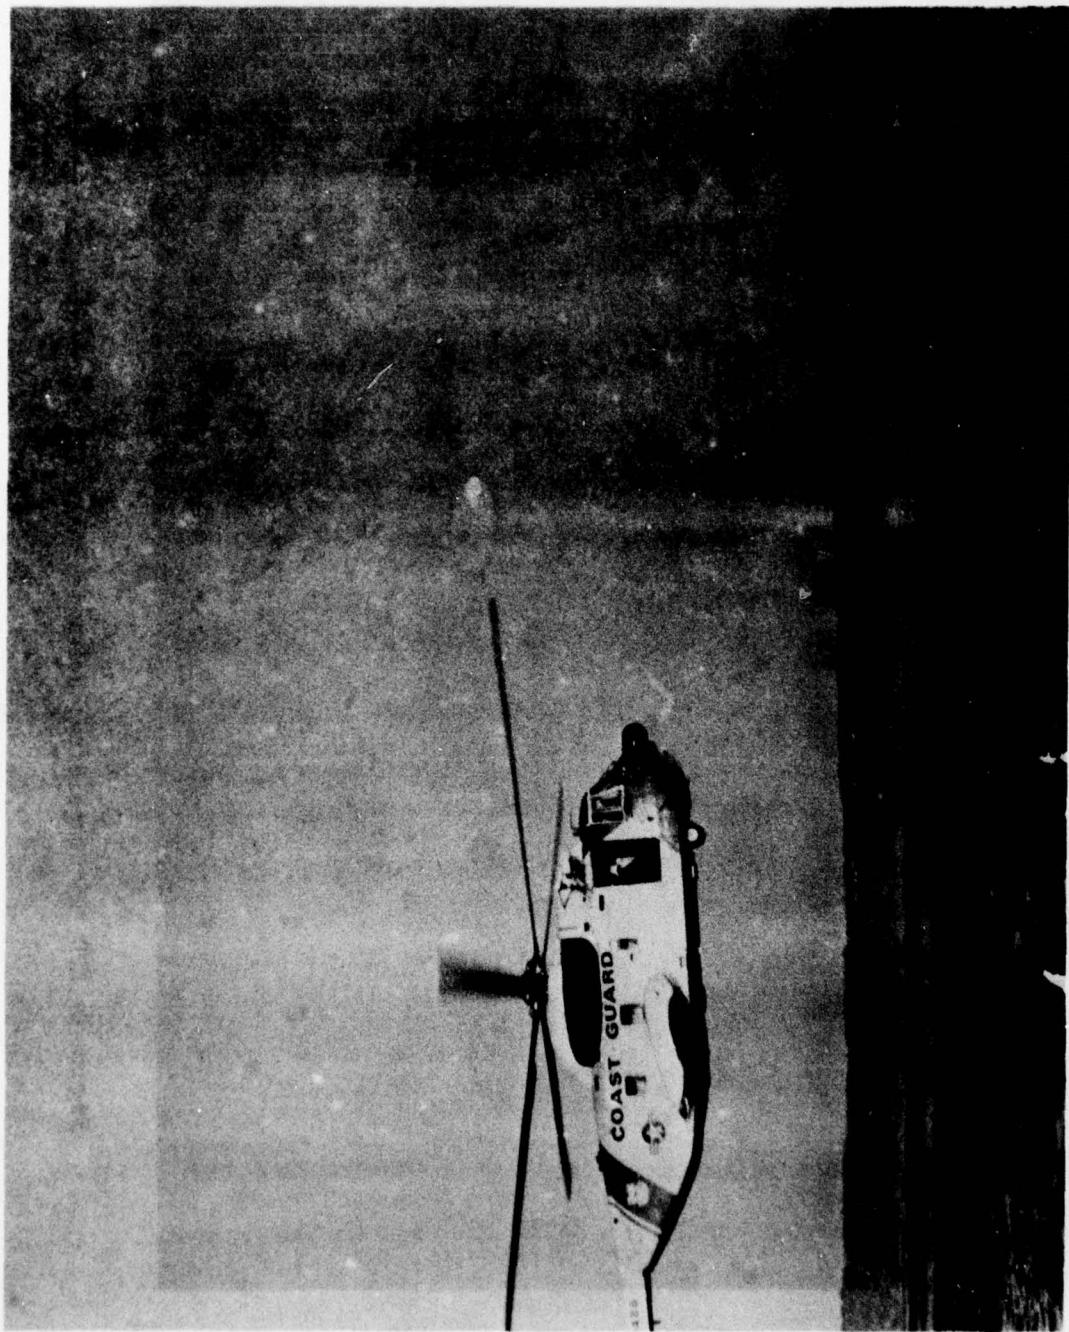
(9) Helicopter approached raft on its untethered (the unweighted) end. Raft turned over and stayed upside down with loss of sand bags. Refer to Figs. 7 and 8.

Figure 7- RFD '25' Capsizing: Refer to Table II(9) (NASA Photograph)

Figure 8- RFD '25' Capsized: Refer to Table II(9) (NASA Photograph)

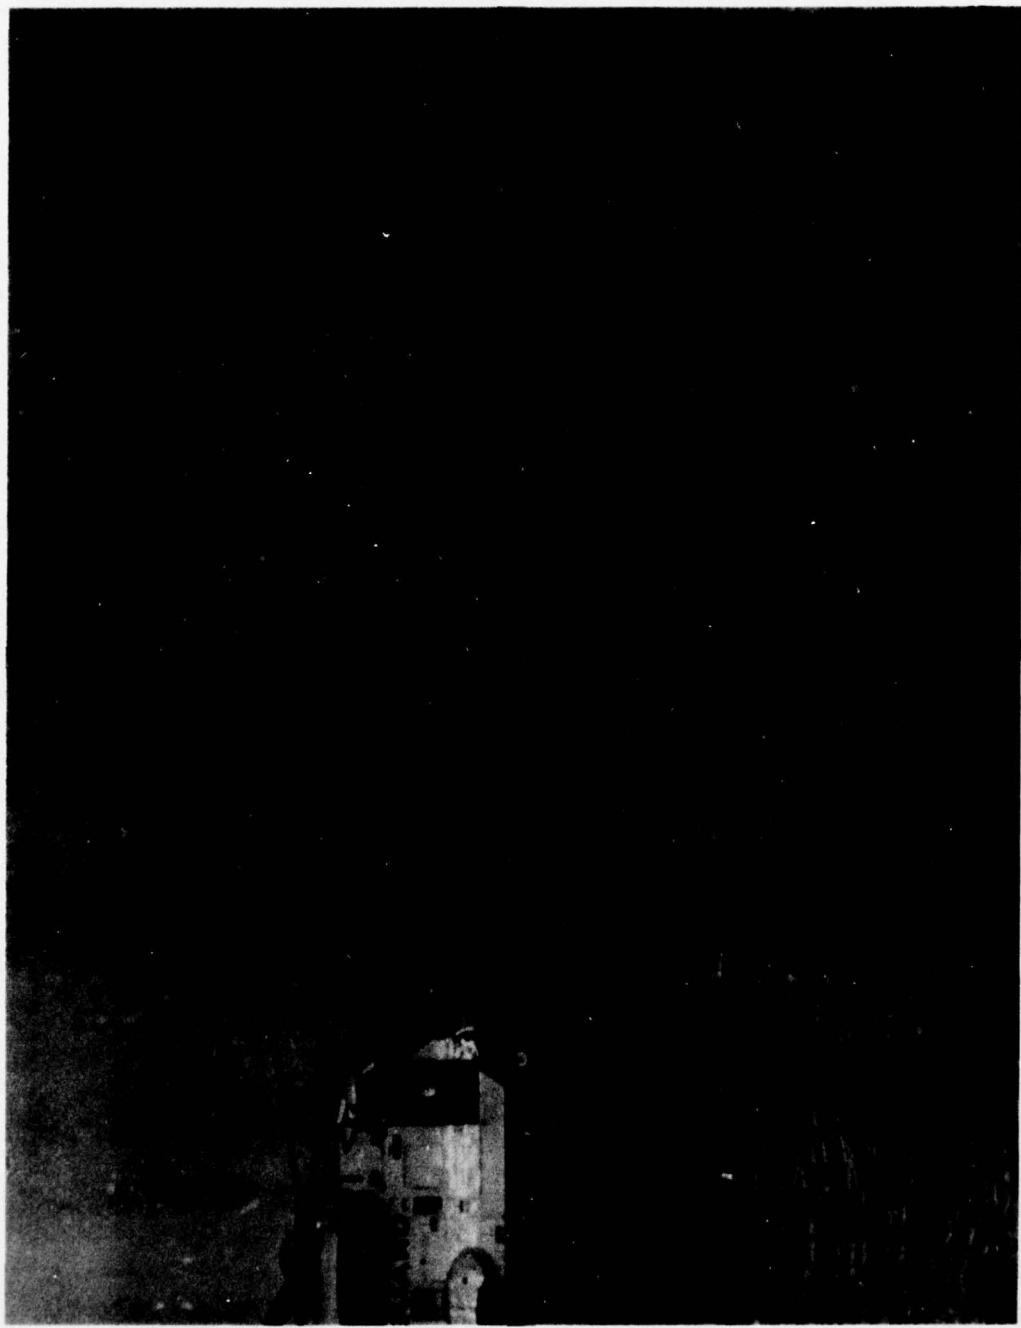
(10) Swimmers righted raft. Helicopter approached raft at 10-foot altitude. Raft turned over. Refer to Fig. 9.

Figure 9- RFD '25' Capsizing: Refer to Table II(10) (NASA Photograph)
